Z1800-Series

Technical Support Bulletin Manual

Z1800-SERIES TECHNICAL SUPPORT BULLETIN MANUAL

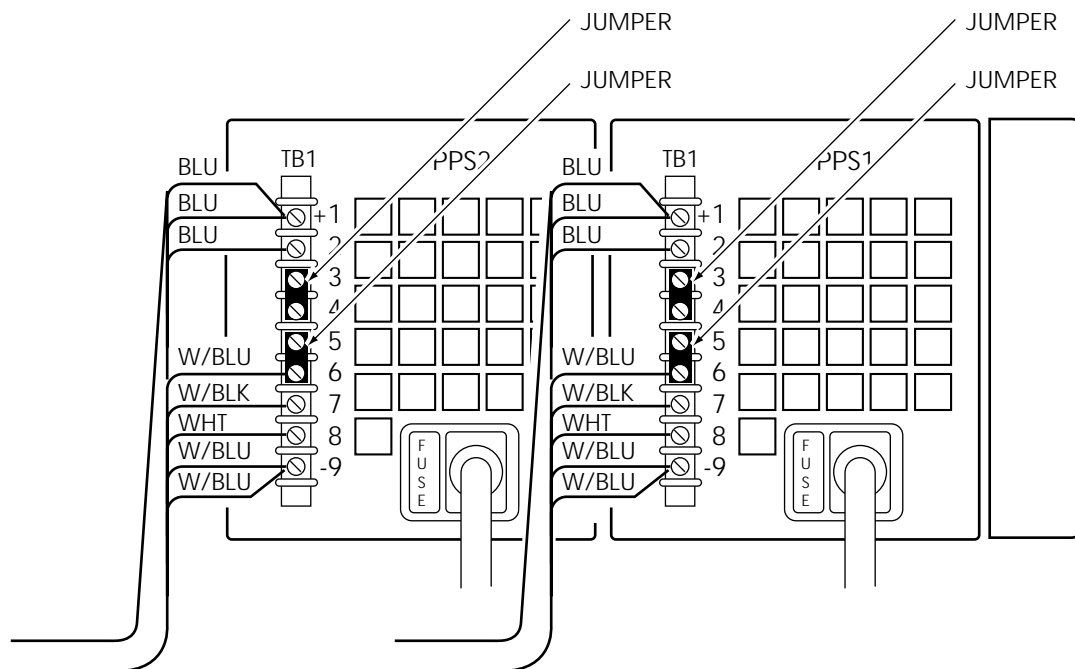
Teradyne's internal quality checks have indicated that some Z1800-series testers may have the local sense jumpers on the two adjustable power supplies (P/N 61428, which are part of the Dual Programmable Power Supply Assembly, P/N 45165).

Locate the rear of the power supplies, and determine if the local sense jumpers are connected between terminals + and 2, and terminals 8 and - of both power supplies. Power supply jumpers should be on terminals 3 and 4, and 5 and 6 only. All other jumpers should be removed. (See the illustration below.)

Rear view of programmable power supplies

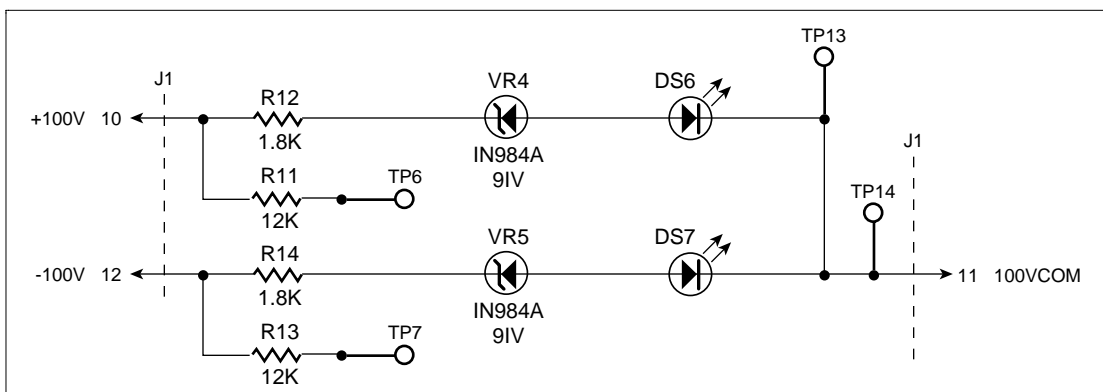
The circuit that indicates the presence of +/- 120 volts may overheat and damage the LED power supply display board (P/N 45034 & 45354 for Z1800 and P/N 45354 for the Z1820). The power rating of the current limiting resistors is too small for the tolerance of the zener used in the circuit. The worst case could permit up to 840 milliwatts to be dissipated through the 500 milliwatt resistor.

Circuit before change

- Request a new revision of the board from Teradyne.
 - Modify the board as instructed below.
1. Remove the LED power supply display boards (45034 and 45354 for the Z1800 and 45354 for the Z1820). (See the illustration below.)

2. Remove resistors R12 and R14 and zeners VR4 and VR5.

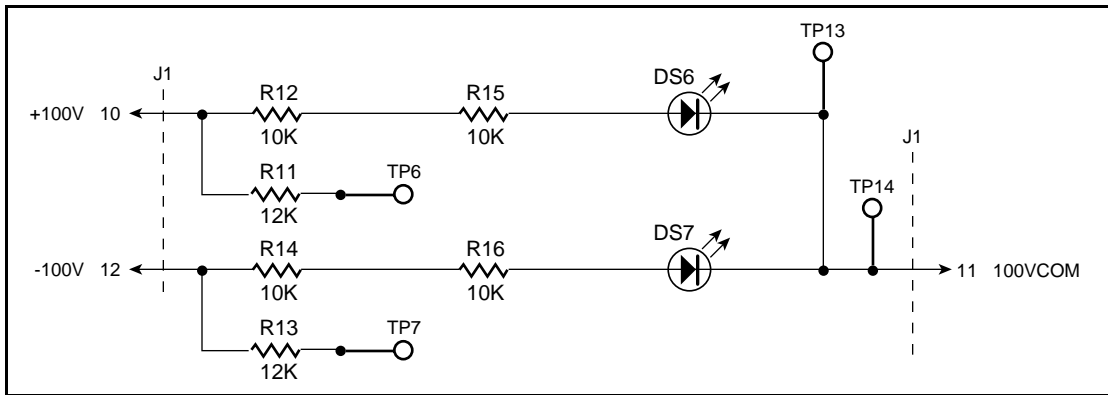
Circuit after change

3. Replace R12 and R14 with 10K-1/2 watt resistors. (See the illustration below.)
4. Replace VR4 and VR5 with 10K-1/2 watt resistors. (See the illustration below.)

5. Replace the display board(s) in the system.

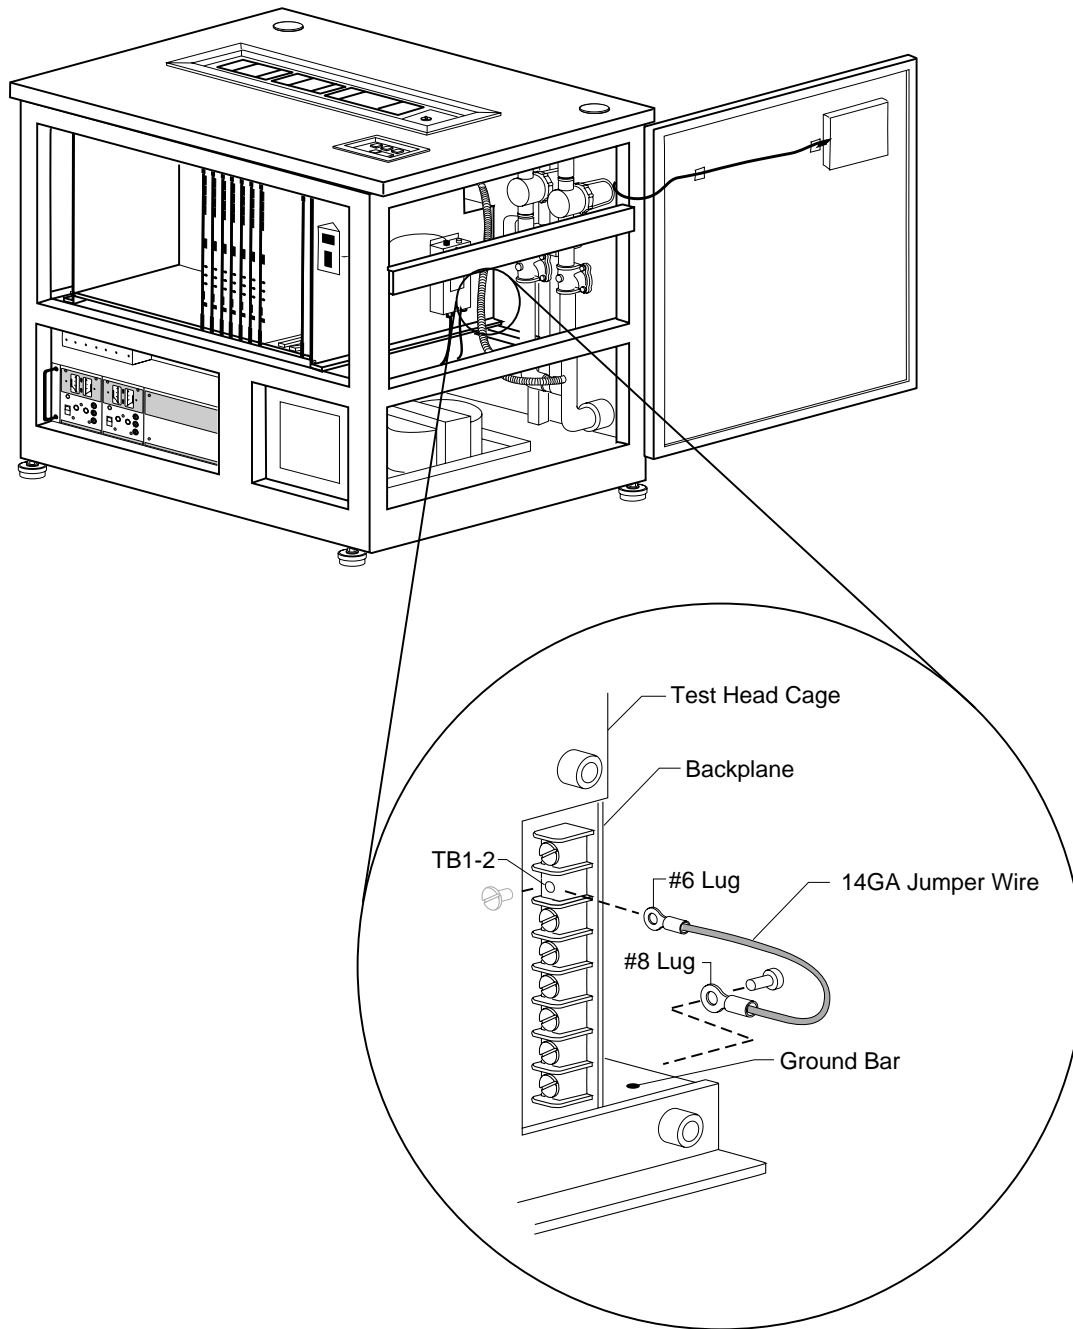
In some Z1800s, THC threshold diagnostic tests will occasionally fail. The failing data is usually out of range by approximately 20mV. The failures are caused by differences in the THC ground and the ATB ground. The grounds are approximately 20mV apart because of excessive resistance between them.

You will need a 6"-8" 14GA jumper wire terminated with a #6 lug on one end and a #8 lug on the other.

1. Shutdown the tester and remove AC power.
2. Unscrew TB1-2 on the backplane. Access to the backplane screws is from the front of the tester.
3. Add the #6 lug terminator to the screw on the backplane, being sure also to reconnect any other wires previously connected to TB1-2. You may need to use a longer screw to accommodate the addition of the ground wire.
4. Insert a 1/4" to 1/2" long #8 screw into the other lug and connect it to any threaded unused hole in the ground bar.

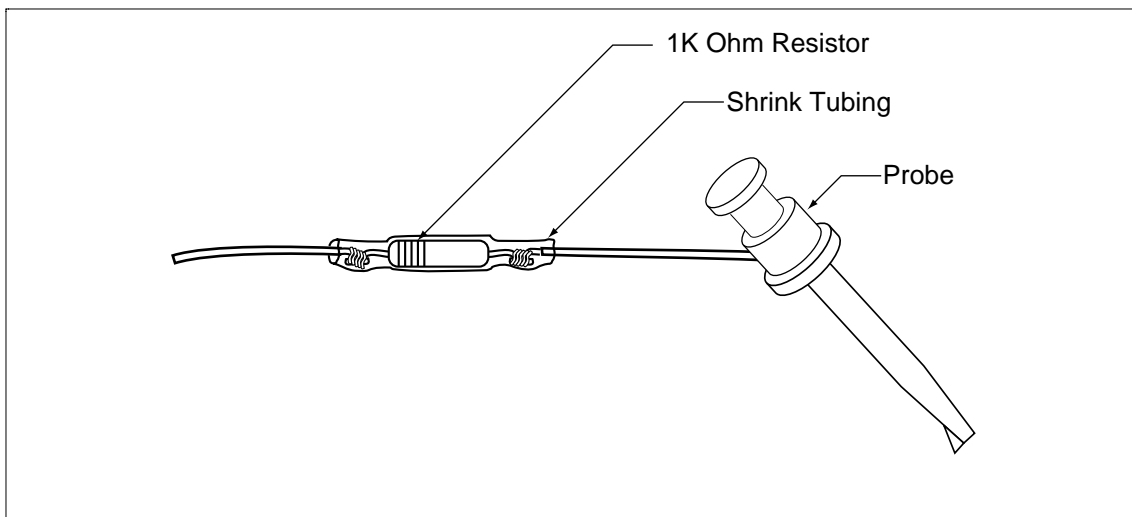
Some of the operational amplifiers (op amps) were changed to a more reliable type on the Z1800-Series Analog Test Board (ATB) (PN 45556/7 Rev C or higher and PN 43016/7 Rev M and higher). These op amps may be sensitive to the meter leads used during ATB calibration. Teradyne recommends that you modify the meter leads used in ATB calibration.

Add a 1K Ohm resistor to the probe end of both the positive and negative lead.

This modification will prevent the op amps from oscillating during calibration.

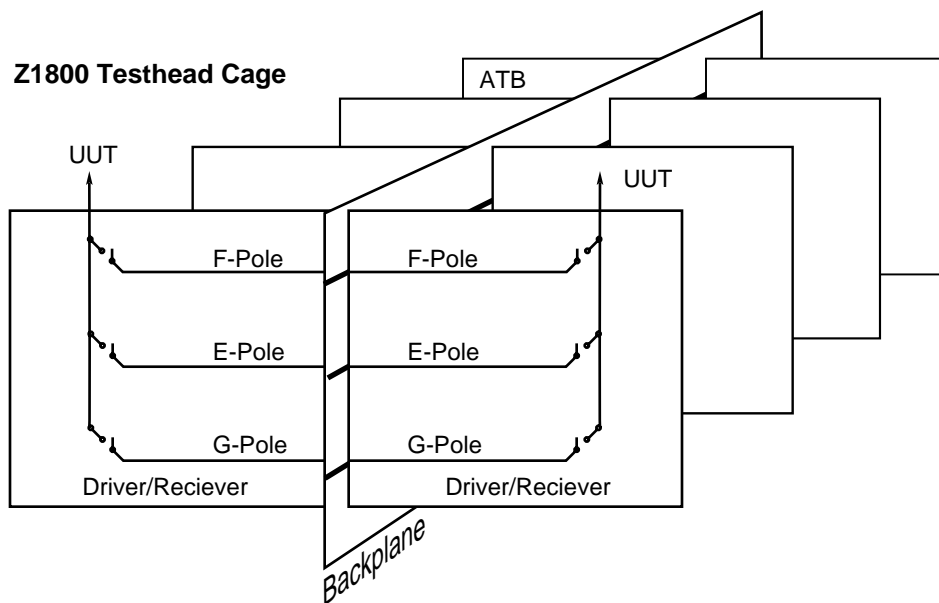
The problem occurs when using the tester as a voltmeter, i.e. in Test V mode or Test V Stim V mode. This situation requires the node to be measured on the unit-under-test (UUT) to be connected to the tester's measurement system, via the F-Pole. When this connection is made there is an initial current spike caused by the charging of the inherent system capacitance.

This capacitance consists of the tester backplane wiring, all the driver/receiver cards and the measurement system, ATB.

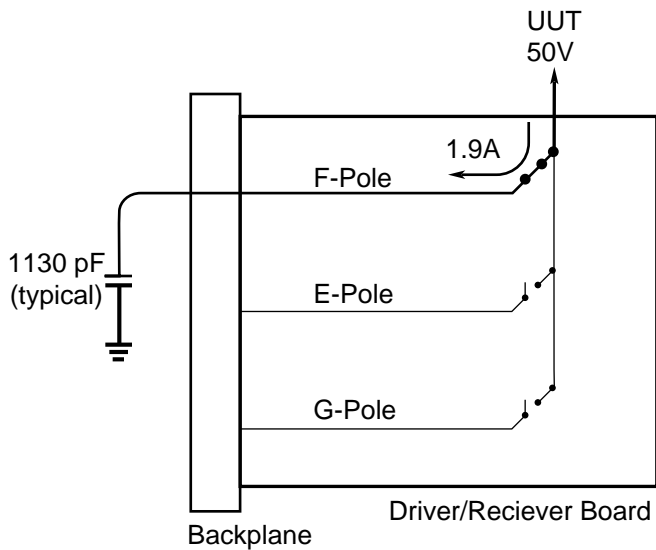
The MAXIMUM current rating for the reed relays is 500 mA. The effect of carrying currents in excess of this rating will be a reduction in the life of the relay. If this occurs often on the same node the F-Pole relay will “stick” and will remain constantly closed.

Relays that fail in this “short circuit” mode must be replaced.

Voltage being measured	Recommended resistor
less than 12 V	none
12 V to 25 V	50 Ω
25 V to 50 V	150 Ω
50 V to 100 V	300 Ω

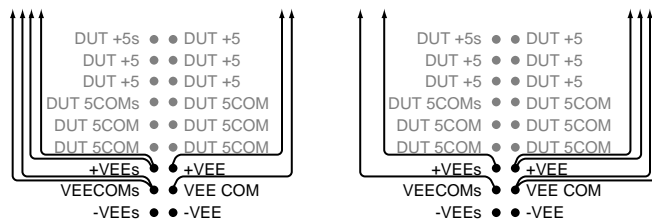
In most customer applications and programs this discrepancy does not affect production testing because Vee power connections have one power probe and one sense probe with the same gauge wire. However, if your fixtures were originally wired to make use of heavier gauge wires or probes for power pins, and lighter gauge sense wires, you may wish to correct your fixture wiring by switching the power and sense connections for each of the two power supply outputs.

Original Wiring

Corrected Wiring

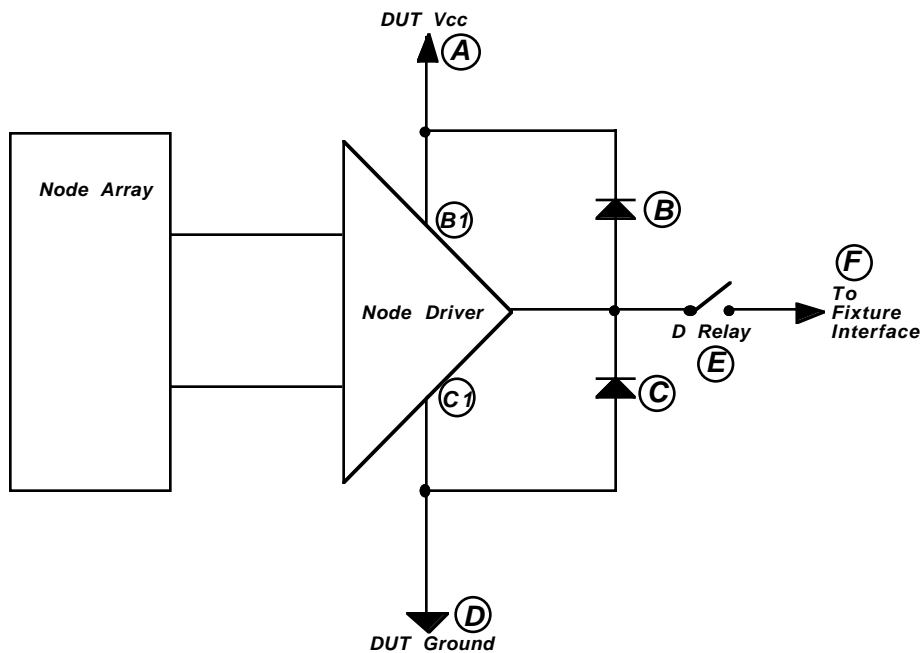
If the voltage on node (*F*) exceeds the voltage at *Vcc* (*A*) and when the D Reed (*E*) closes, the two voltage sources are shorted together through the clamping diode (*B*) or driver transistor (*B1*). Conversely, if the voltage on node (*F*) is below the ground potential (*D*) and the D Reed (*E*) closes, the voltage source is shorted to ground through a clamping diode (*C*) or driver transistor (*C1*).

Even if the voltage at (*F*) is within the specified voltage, transistor (*B1*) could be damaged if the driver is trying to drive HIGH (stim high) when (*F*) is accidentally connected to the voltage source. Similarly, transistor (*C1*) could be damaged if the driver is trying to drive LOW (stim low).

Steps 7 through 10 in the procedure below prevent shorting the two voltage sources together.
